**STEILACOOM HISTORICAL SCHOOL DISTRICT NO. 1
AGENDA**

Special Meeting of the Board of Directors
Wednesday, October 20, 2010 6:30 p.m.

Pioneer Middle School-Steilacoom 511 Chambers Steilacoom, Washington

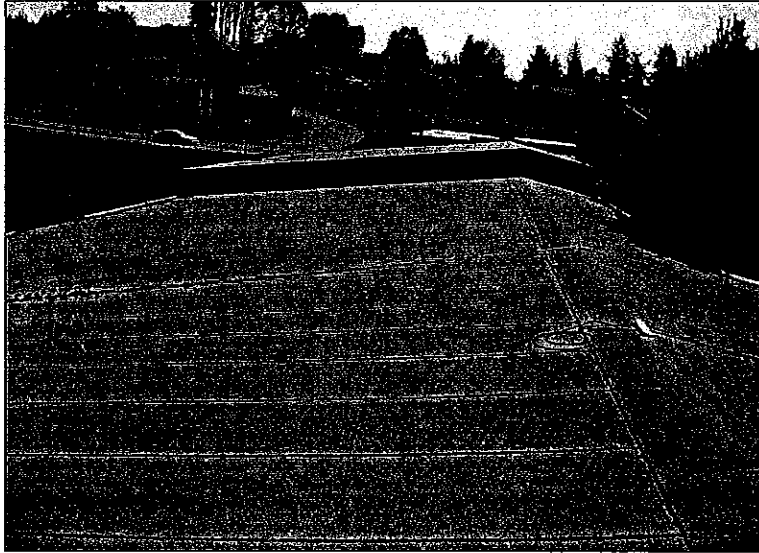
Photograph 57:

Looking east of the north slope of
the North Wing

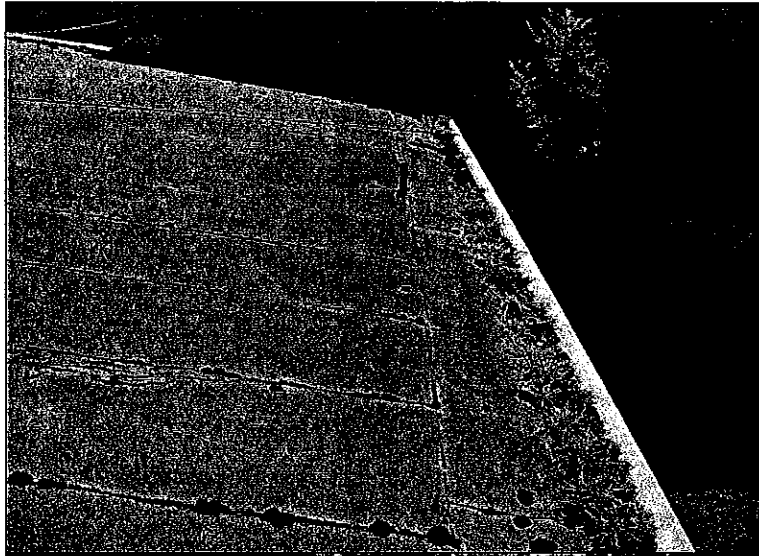
Photograph 59: North Wing

Looking east along south slope, north end of the west roof showing extensive vegetation and algae growth in gutter

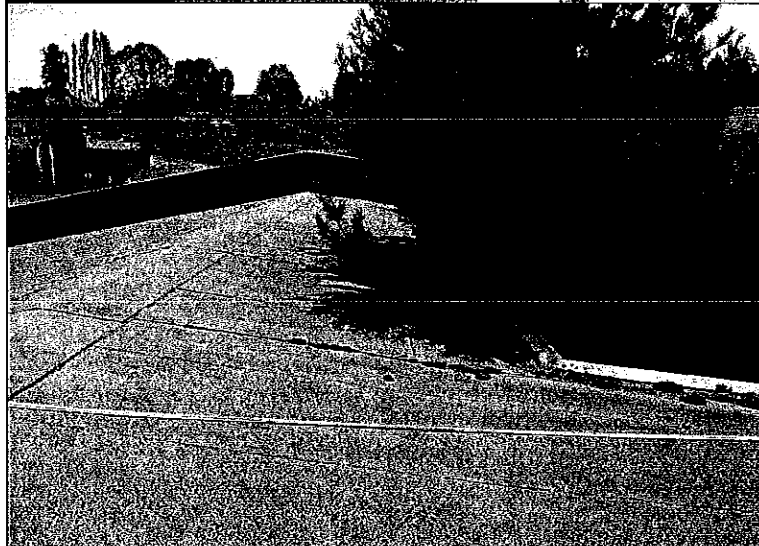
Photograph 61: North Wing

Looking east along gutter edge of central portion of west roof, south slope. Pine trees growing up and over roof. Huge collection of pine cones and vegetative growth

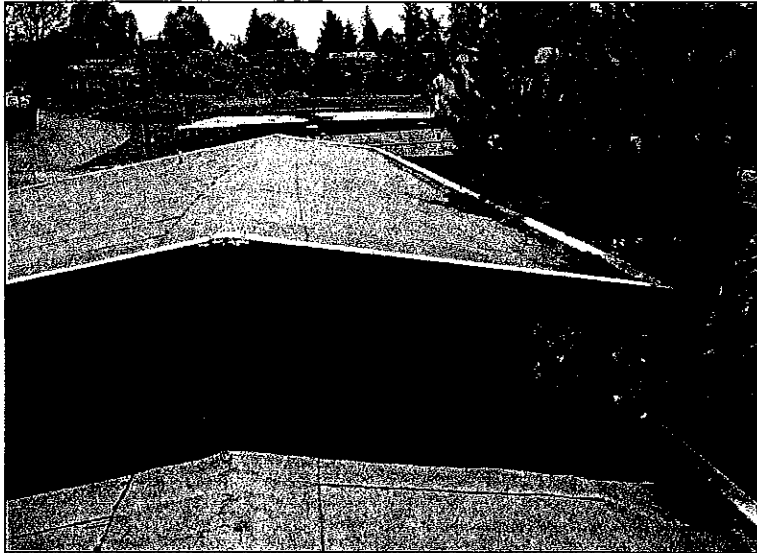
Photograph 62: North Wing

Looking east along south slope of east roof, north wing, note additional collection of pine cones, algae growth and vegetation in gutter area

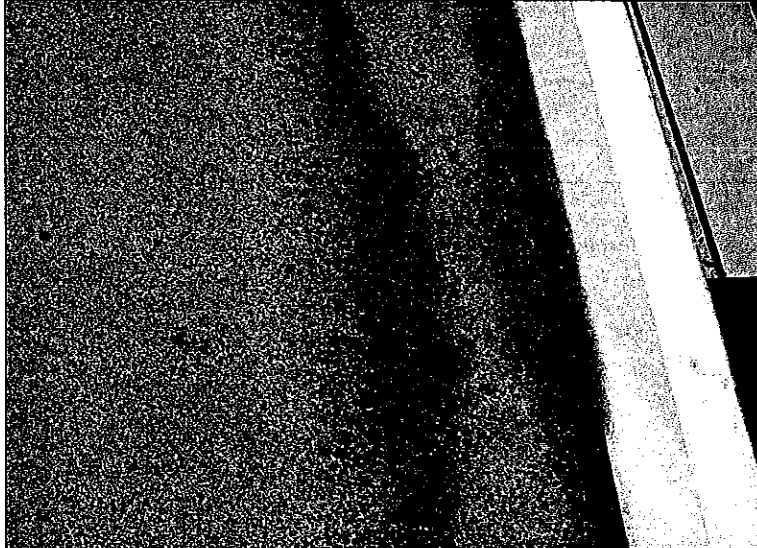
Photograph 63: North Wing

Close up of typical gutter area where granule loss is extensive exposing membrane.

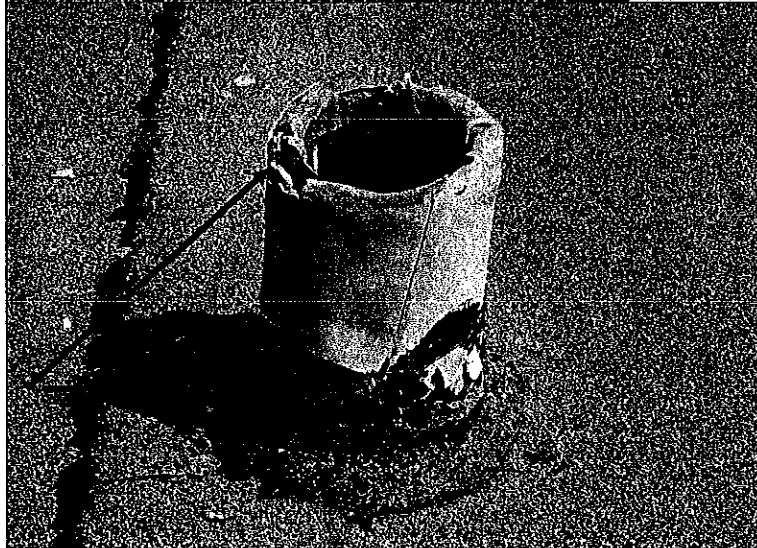
Photograph 64: North Wing

Lead flashing at 4-inch pipe penetration Lead deteriorated with holes open for moisture intrusion

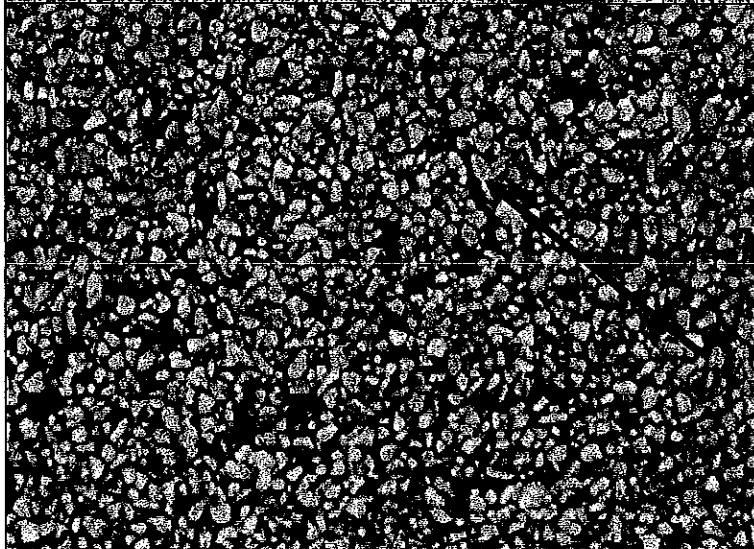
Photograph 5:

South Wing, west roof, north slope.

Fracture in granular surfaced membrane.

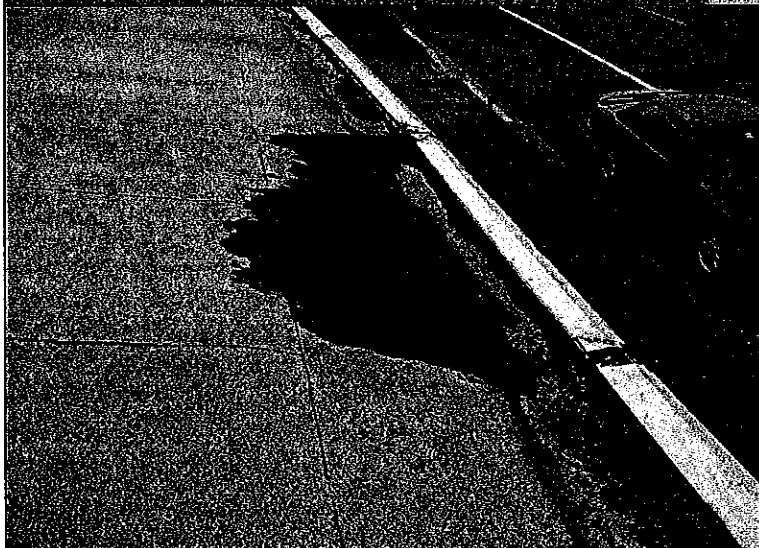
Photograph 7:

South Wing, west roof, south slope.

Large mastic repair in south gutter.

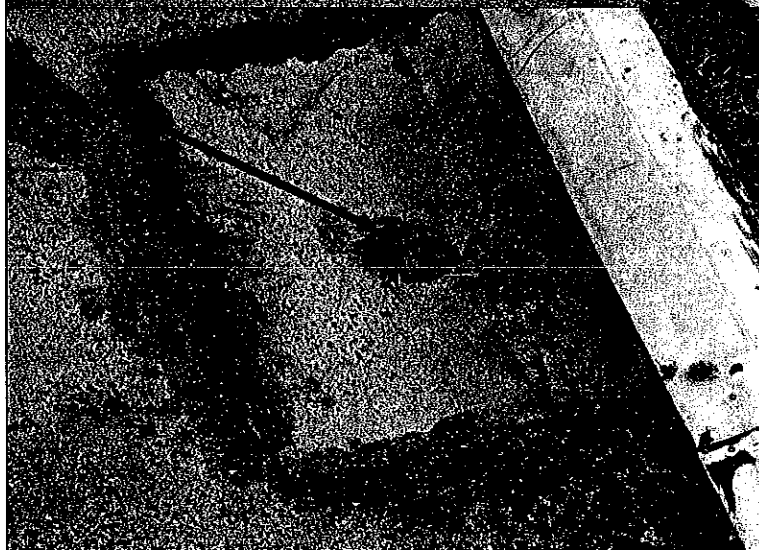
Photograph 8:

South Wing, west roof, south slope.

Repair at drain scupper. Note scupper is plugged with debris.

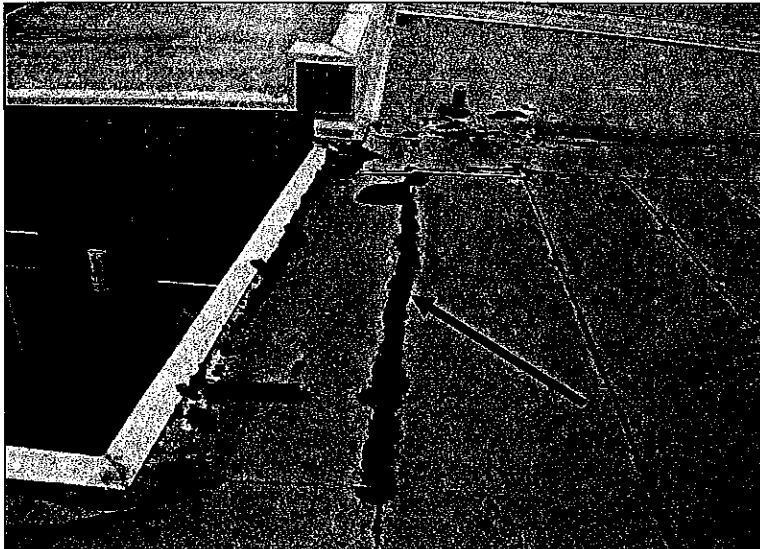
Photograph 14:

South Wing, east roof, north slope.

Mastic repairs along membrane seam at west rake edge.

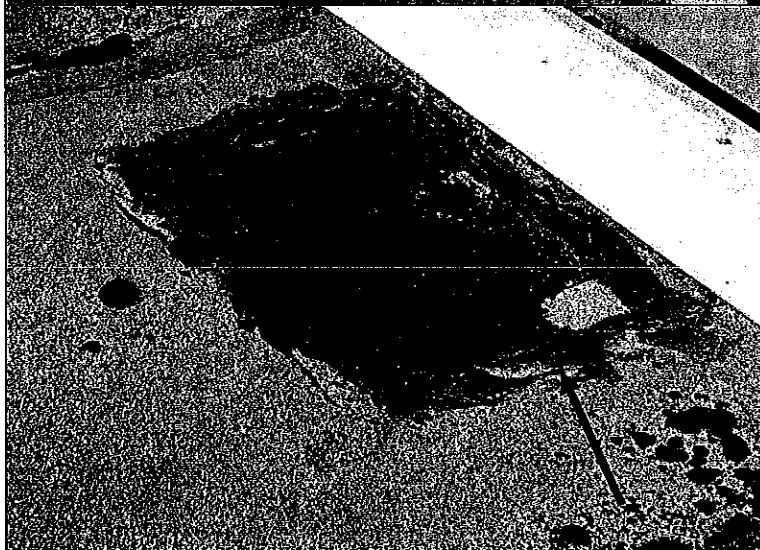
Photograph 23:

Upper Gym Roof, west slope.

Repairs at drain scupper along west slope gutter. Note peeling mastic repair.

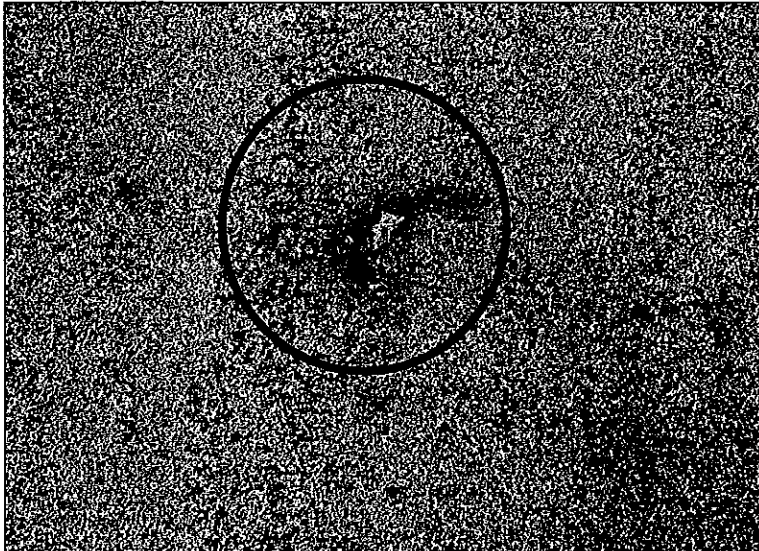
Photograph 27:

Lower North Locker Room Roofs.

Hole through surface of granular cap sheet.

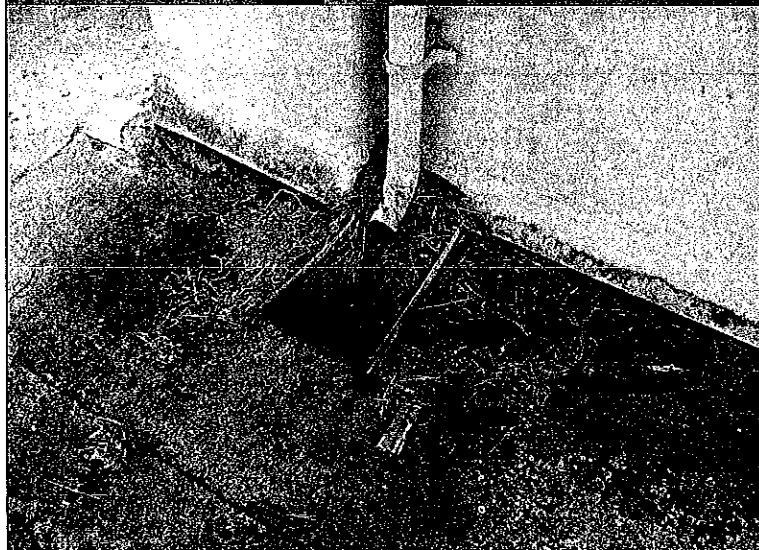
Photograph 29:

Lower North Locker Room Roofs.

Bird nest around base of downspout from upper gym roof.

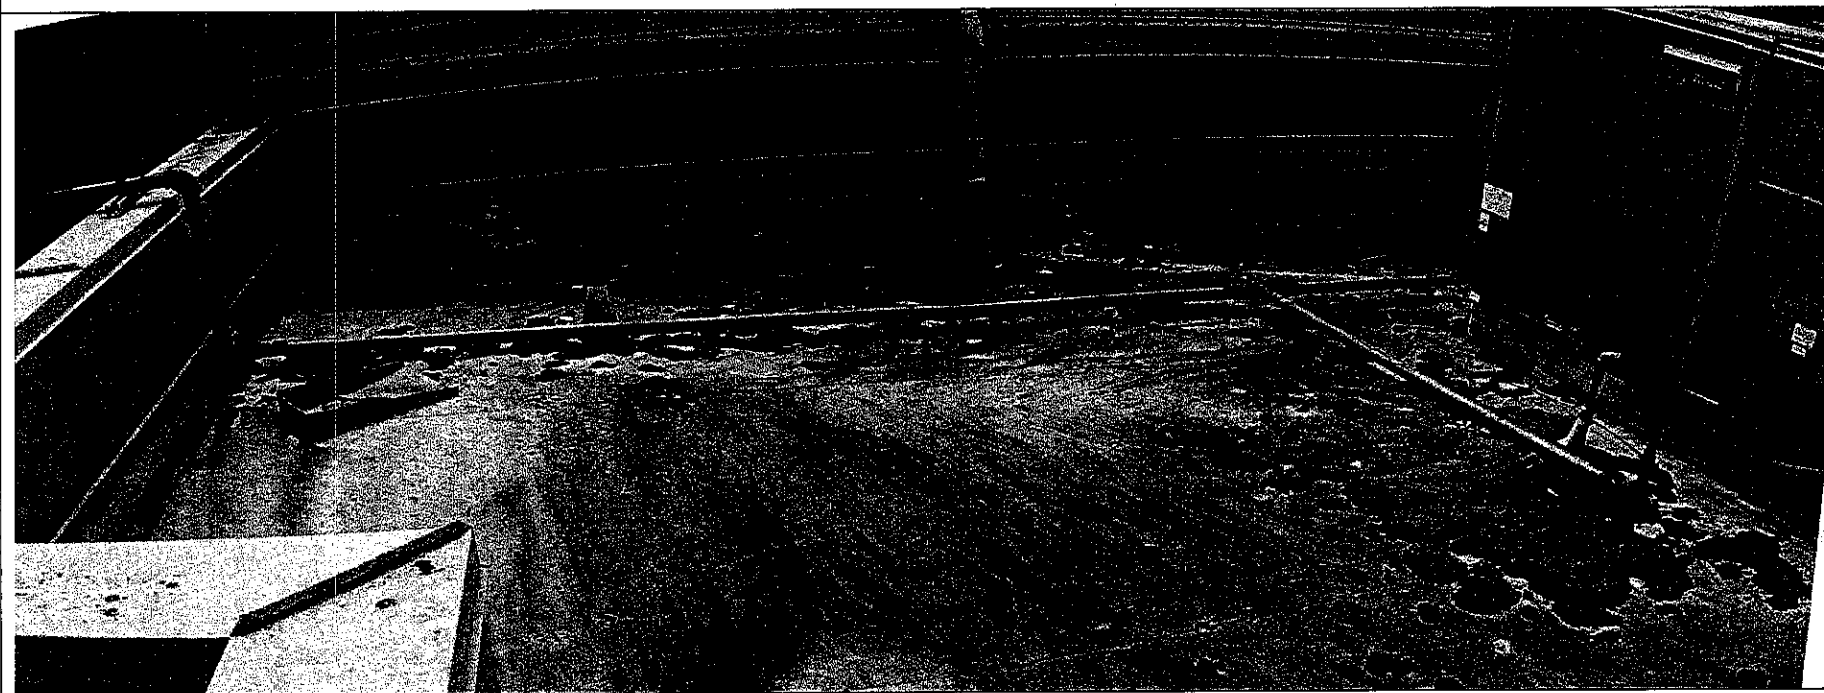
Photograph 38: Pan photo of the north end of the Central Roof area.

Note extensive moss growth on membrane.

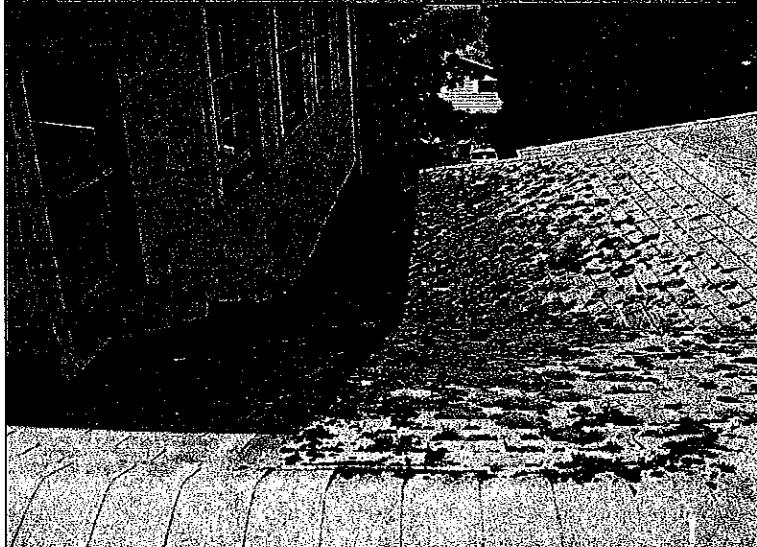
Photograph 42: Old School Building

Lower north end of roof that slopes back to the side of the rising wall

Extensive algae growth and moss to a smooth surface torch grade membrane adhered directly to the stucco wall

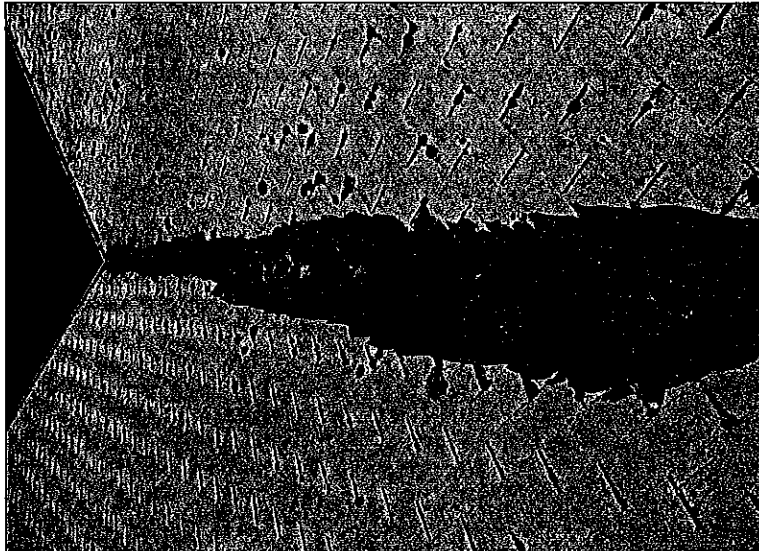
Photograph 47: Old School Building

Looking down the valley on east slope north end where mastic or cold applied application has occurred, it is a cut valley with no metal, appears to be a leak location.

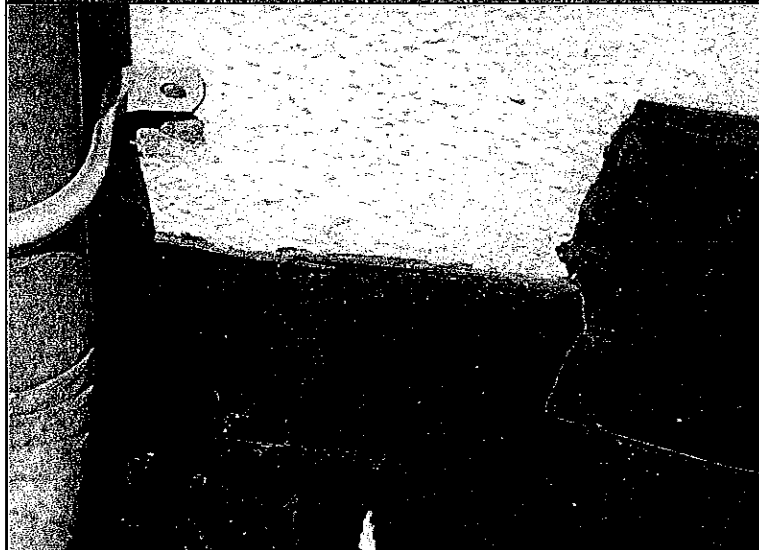
Photograph 48: Old School Building

Close up of a smooth surface torch grade membrane at the up slope edge of the east slope roof used as an up slope roof to wall counter flashing torch grade sealed directly to the stucco wall assembly

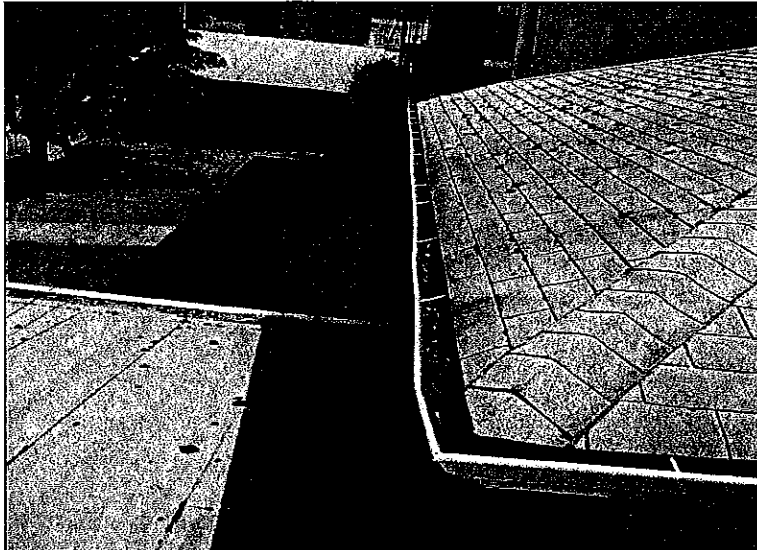
Photograph 53: Old School Building

Looking north at the lower east slope of the south end of the old school showing gutter filled with granules and debris. Spike and ferrules loose and gutter completely plugged

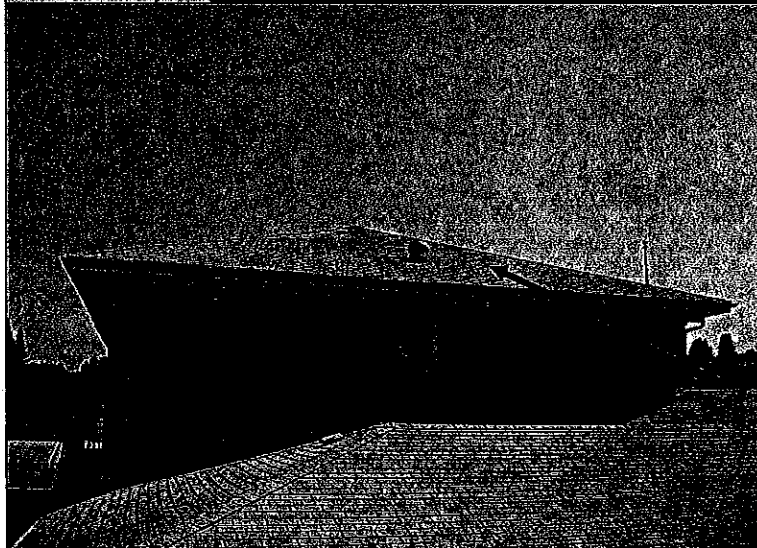
Photograph 54: Old School Building

Looking up at the south slope of the upper roof at the old school extensive shingle tab loss throughout field of south slope
