**STEILACOOM HISTORICAL SCHOOL DISTRICT NO. 1
AGENDA**

Special Meeting of the Board of Directors
Wednesday, October 20, 2010 6:30 p.m.

Pioneer Middle School-Steilacoom 511 Chambers Steilacoom, Washington

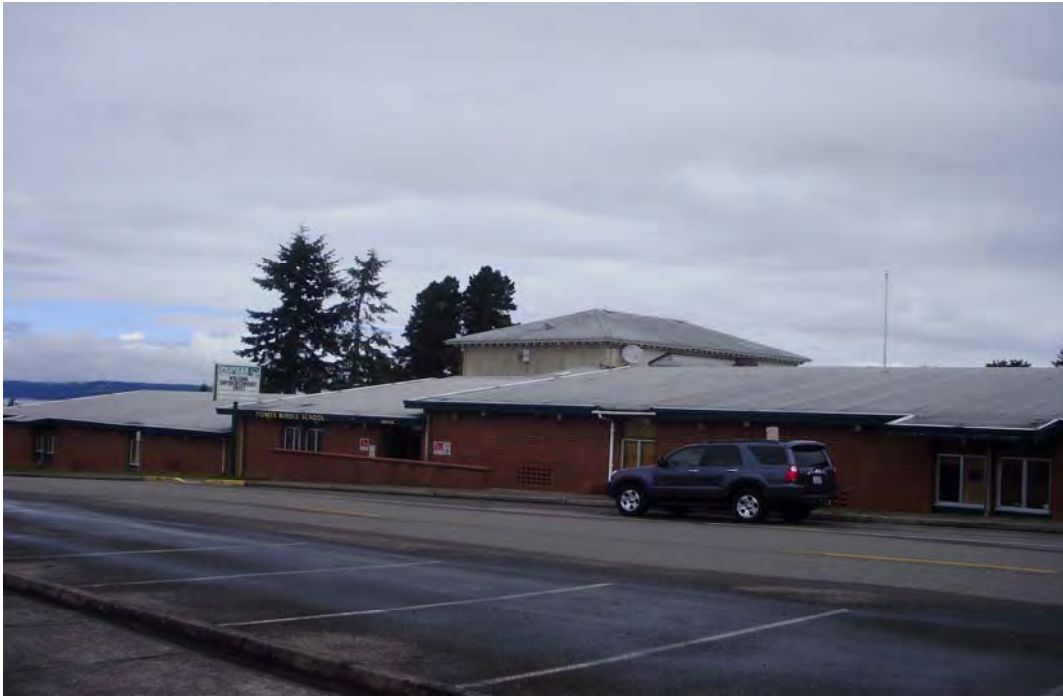
Photo 1: Pioneer Middle School (looking at southeast and southwest wings.

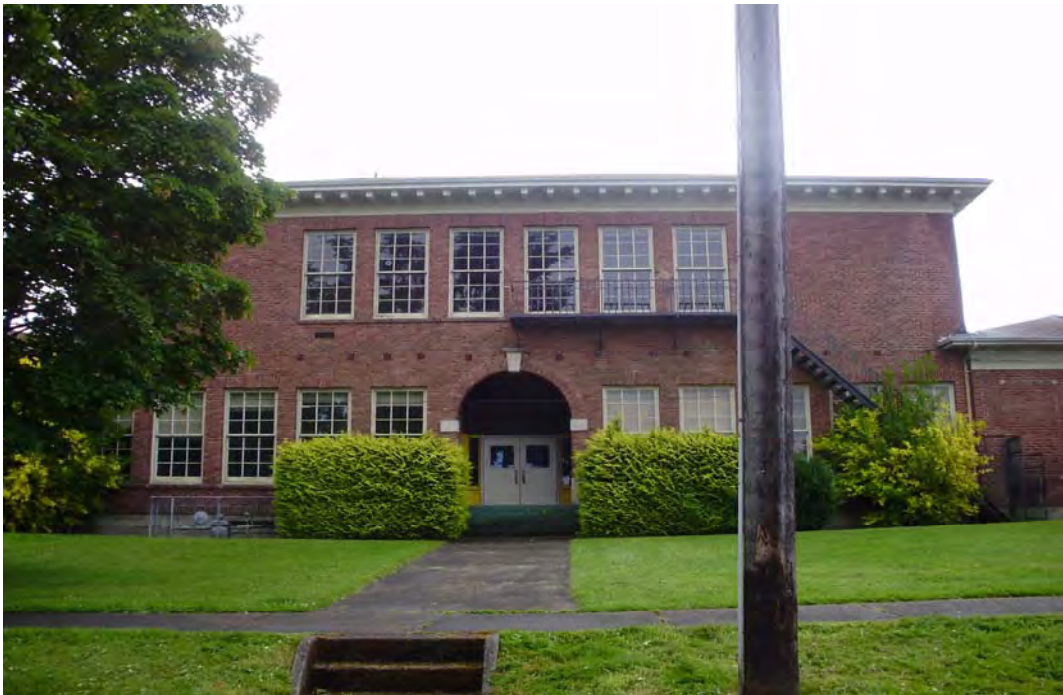
Photo 2. 1920's Building.

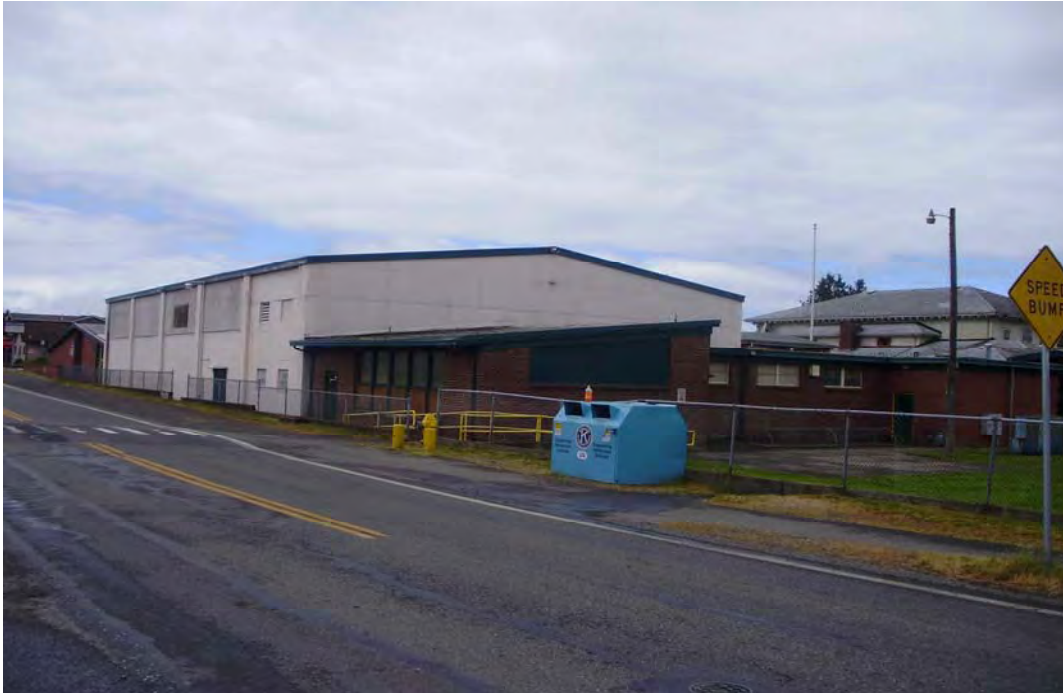
Photo 3: Gymnasium building, northeast classroom and locker rooms.

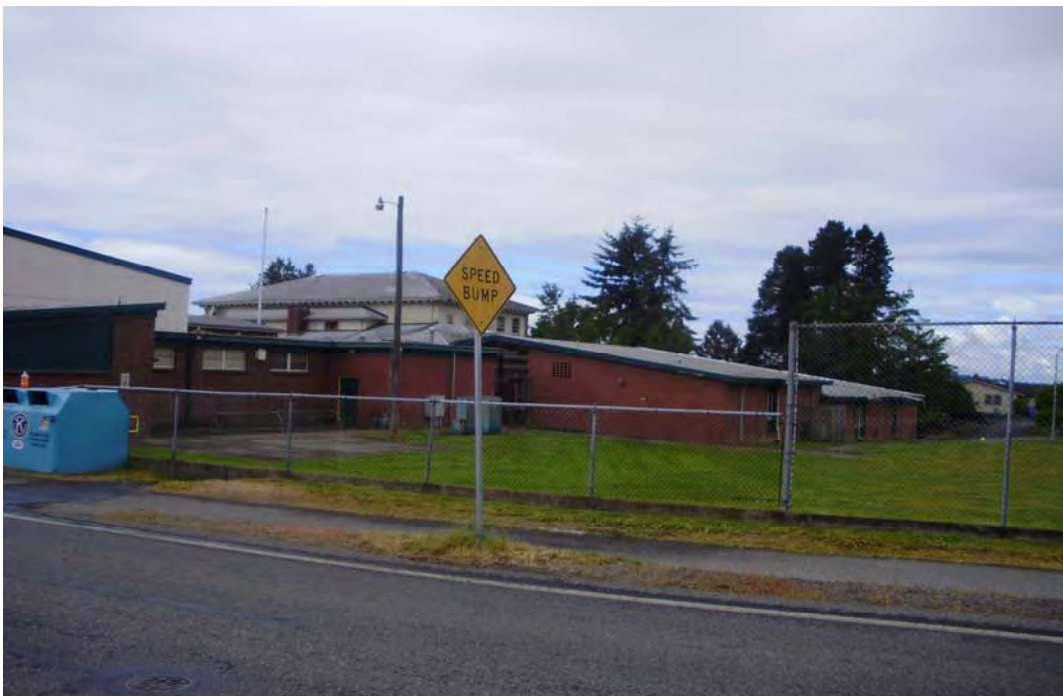
Photo 4. Building on the right are northwest classrooms.

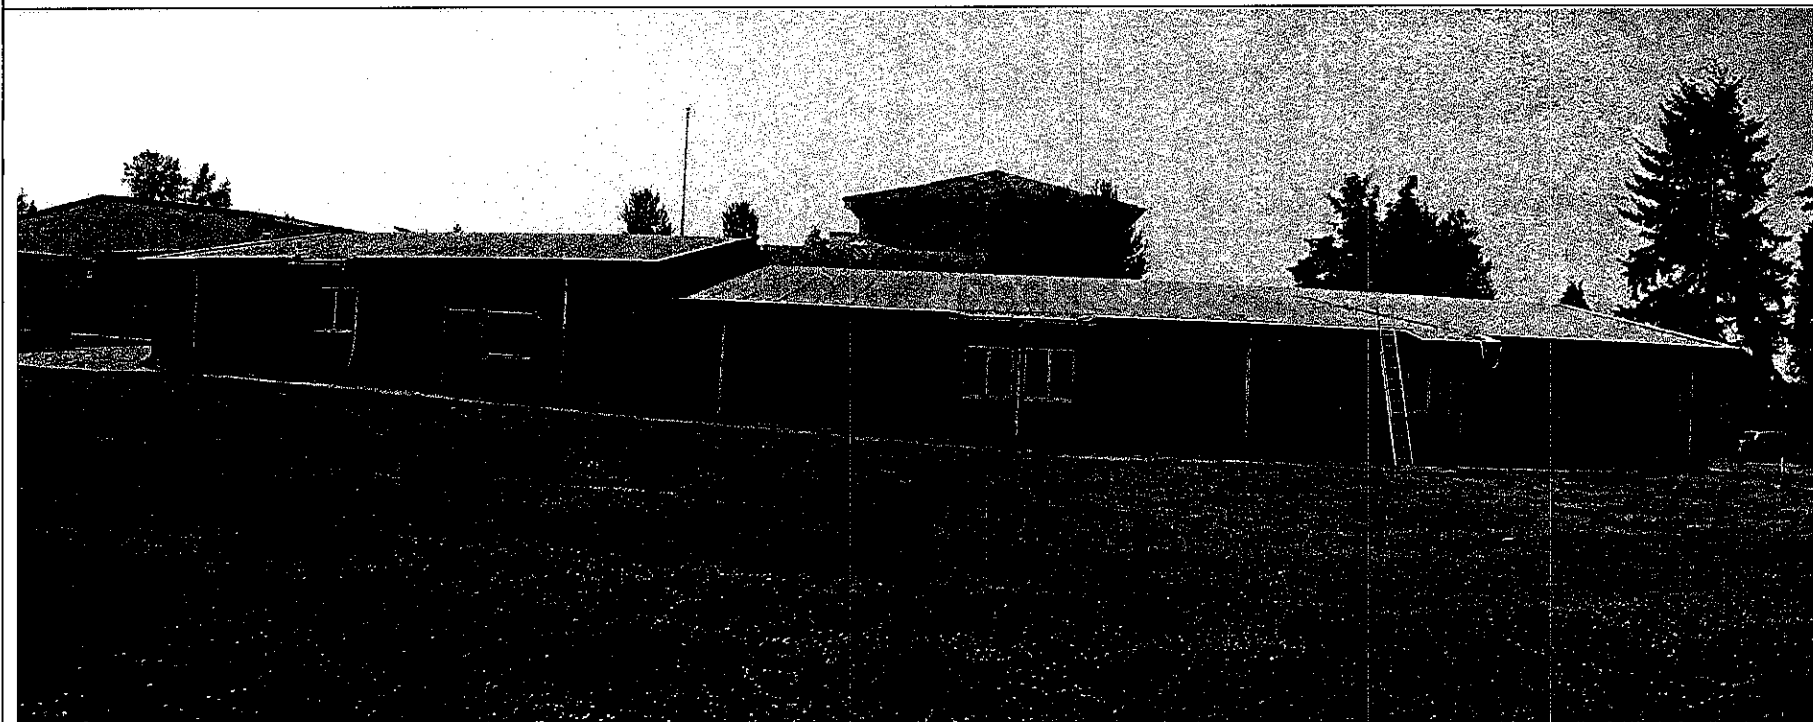
Photograph 56: North elevation of the North Wing

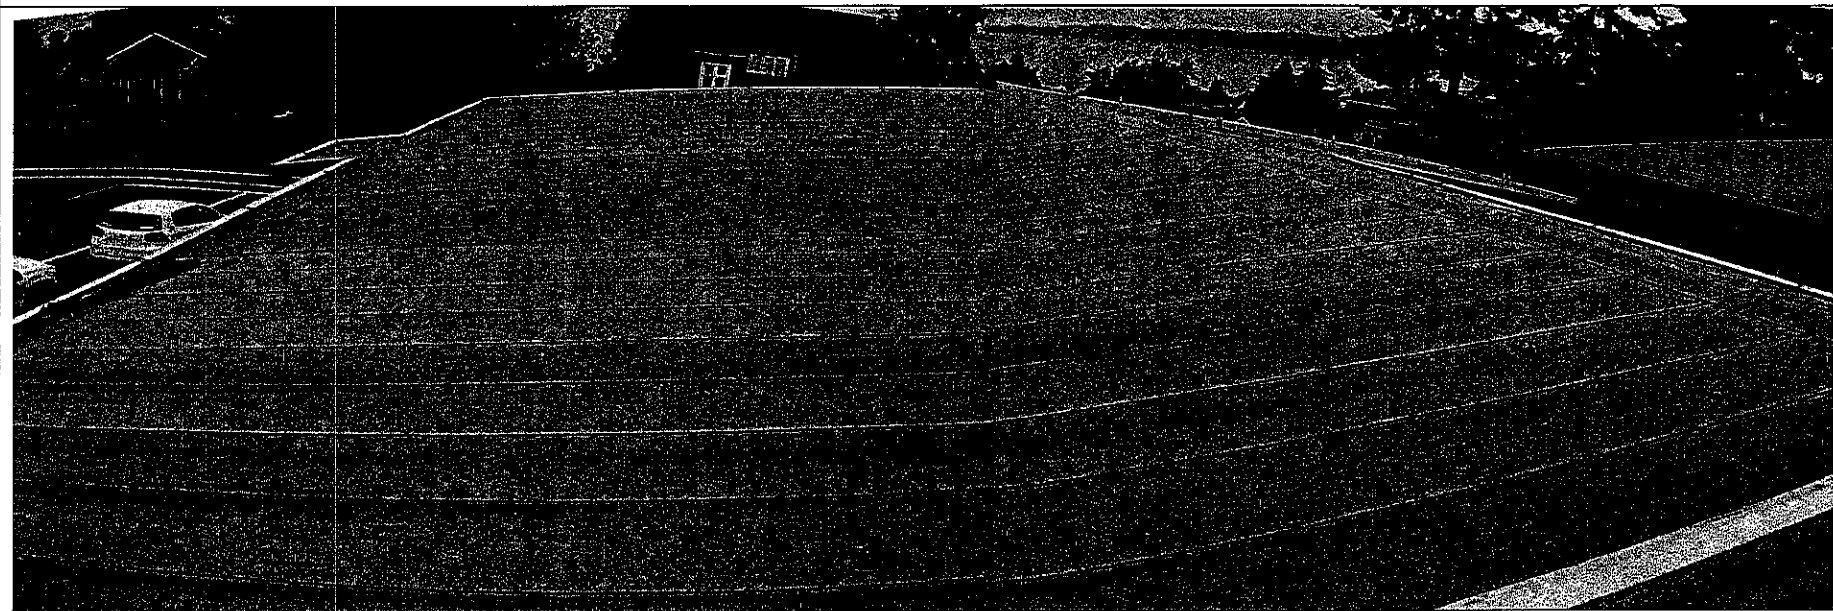
Photograph 2: Pan photo looking west. South wing, west roof area.

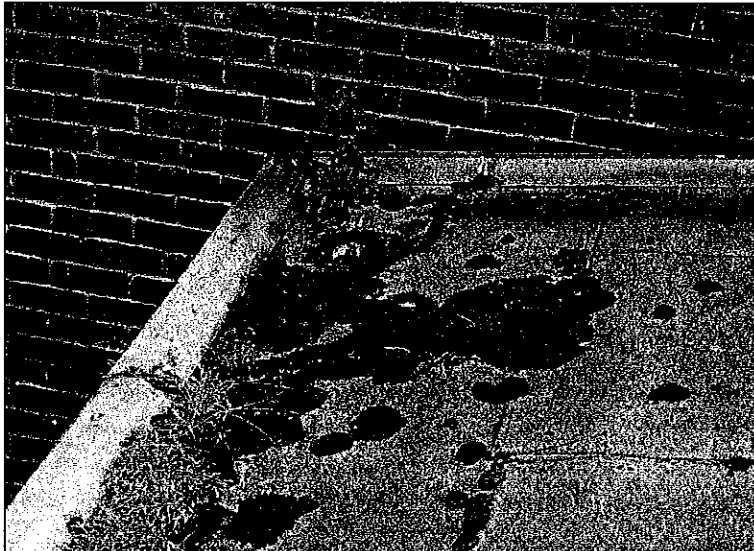
Photograph 3:

South Wing, west roof, north slope.

Moss and vegetative growth in gutter and drain scupper.

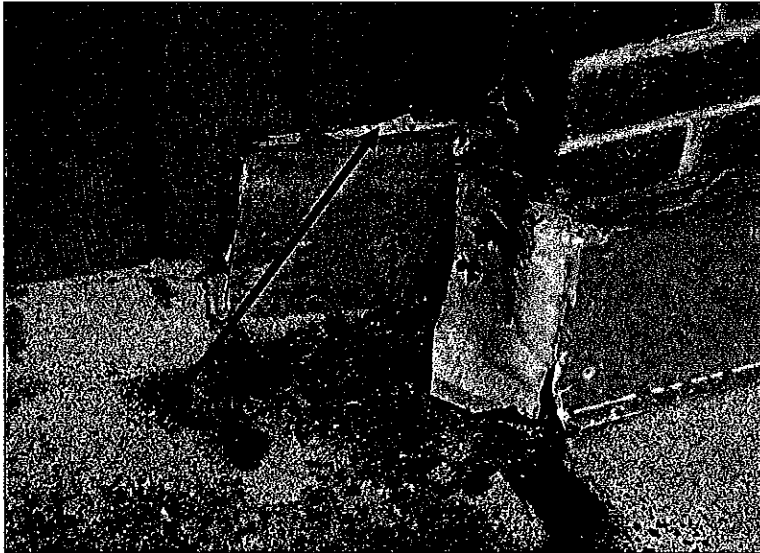
Photograph 9:

South Wing, west roof, south slope.

East end of west roof area at rising wall. Sealant failure at surface mounted sheet metal flashing.

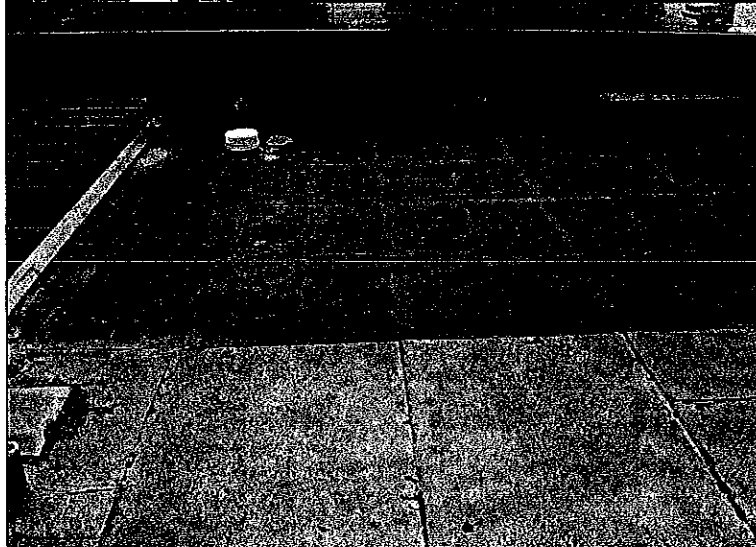
Photograph 32:

Lower North Locker Room Roofs.

Looking east along north perimeter edge showing smooth surface torch applied overlay.

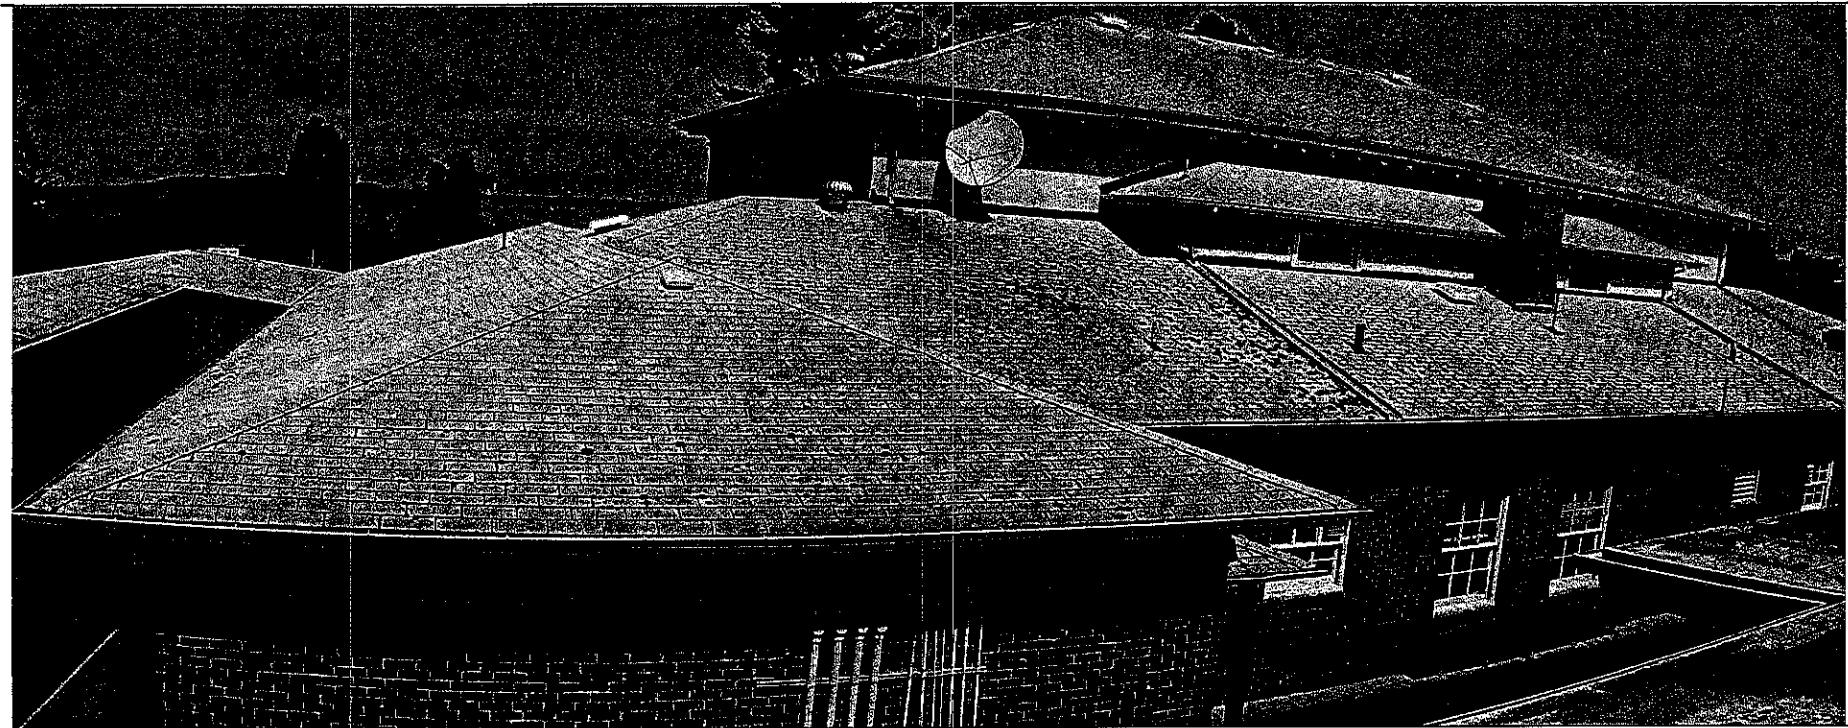
Photograph 40: Old School Building. Panoramic photo of the east elevation

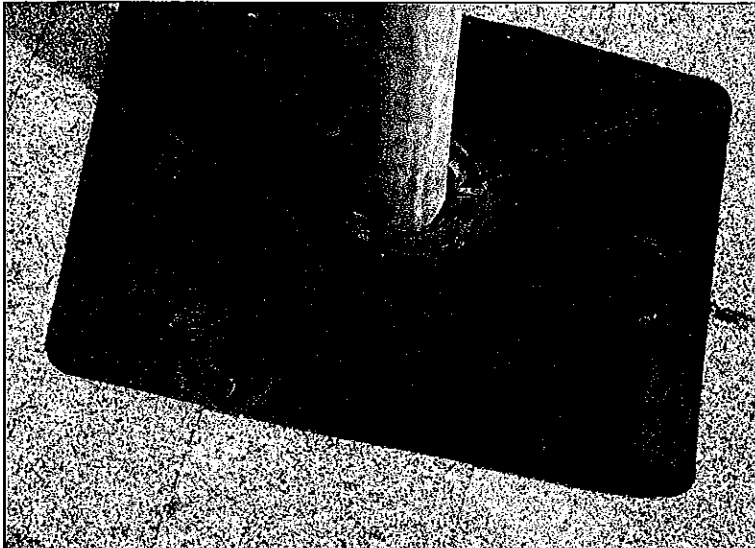
Photograph 50: Old School Building

Close up of rubber pipe boot penetration not secured or sealed around steel pipe penetrating roof
